Black River Area of Concern – Willow Creek Stream Restoration and Enhancement (GL-00E01563-3)

Final Report

December 2021

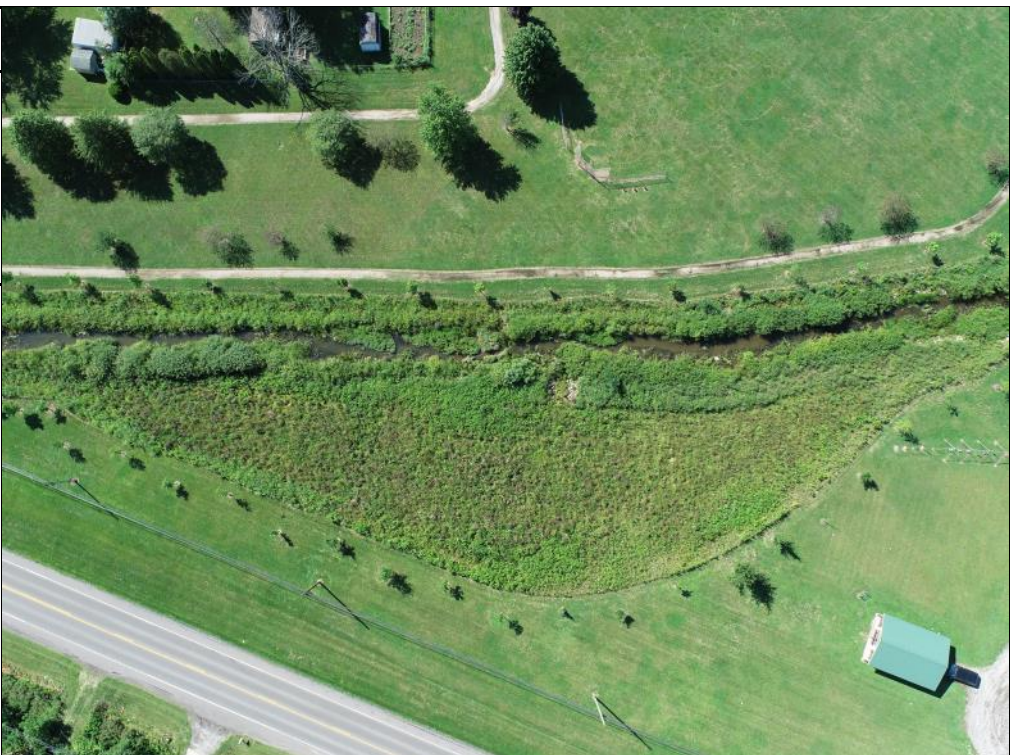
Photo No. 2	Date: 8/5/2020

Direction Photo Taken: N/A		
Description: Aerial view of post-construction conditions at Willow Creek in the Eaton Township Community Park.

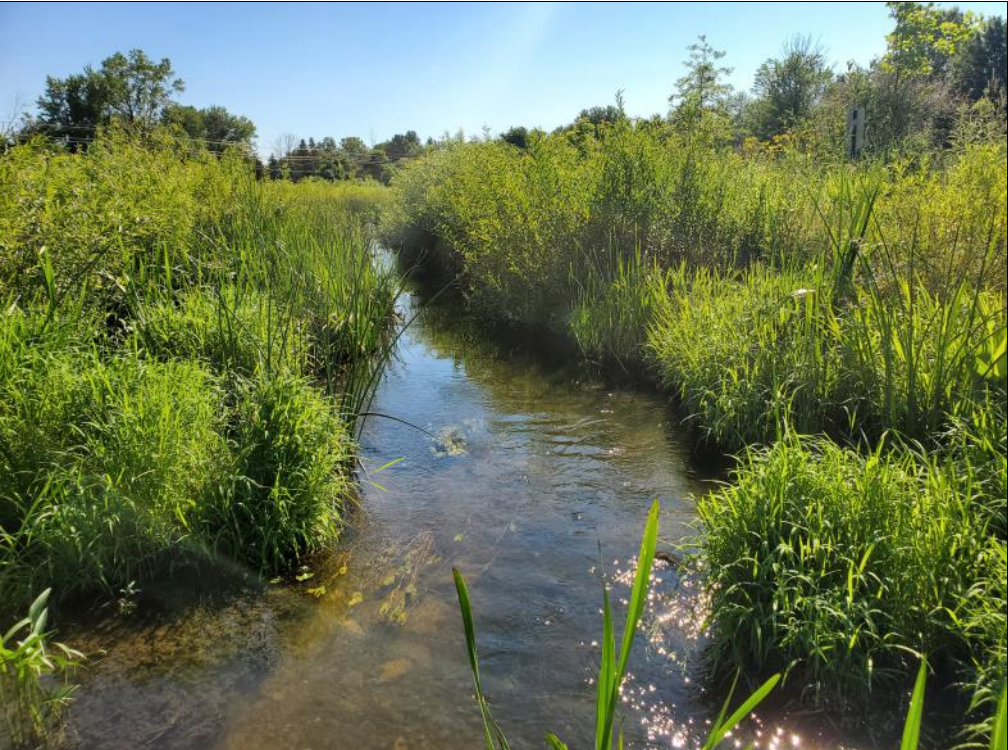
Photo No. 4	Date: 7/18/2019

Direction Photo Taken: East		
Description: Upstream view of post-construction conditions at Willow Creek.

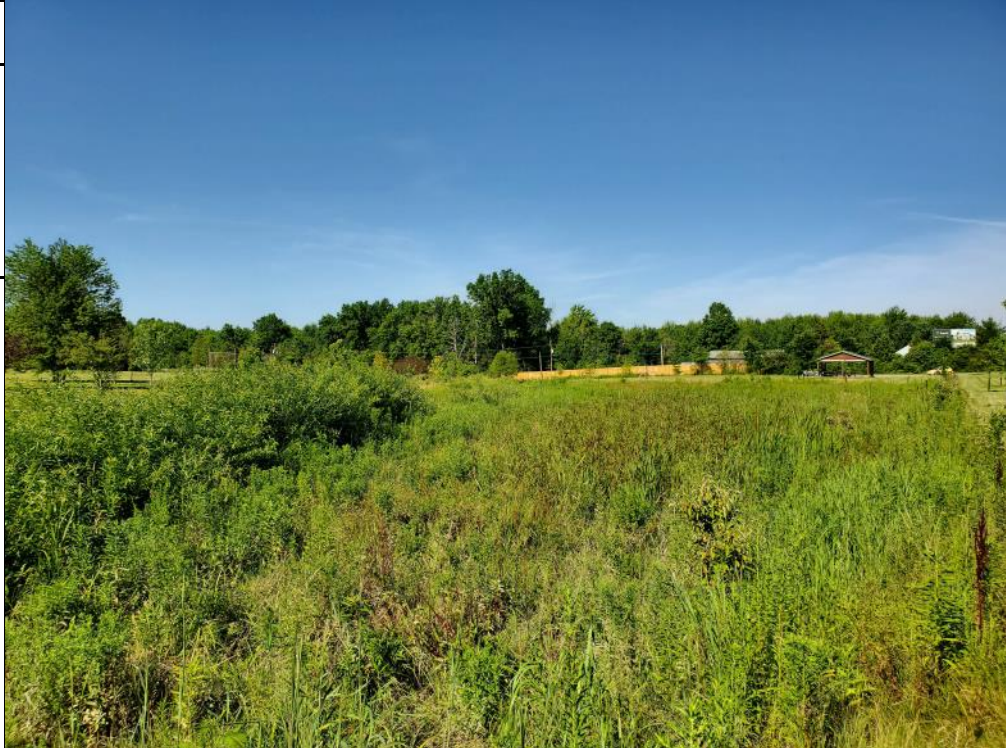
Photo No. 6	Date: 7/18/2019

Direction Photo Taken: West		
Description: Post-construction view of floodplain wetland and restored riparian buffer along Willow Creek.

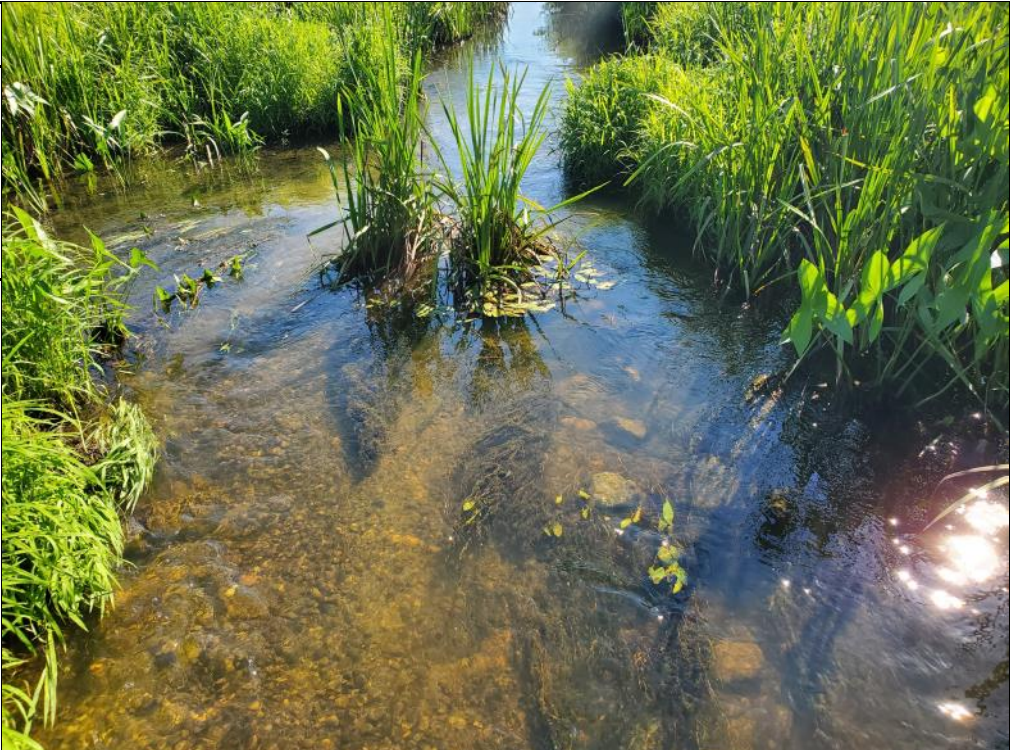
Photo No. 8	Date: 7/18/2019

Direction Photo Taken: Northeast		
Description: Upstream view of aquatic macrophytes serving as habitat in Willow Creek.

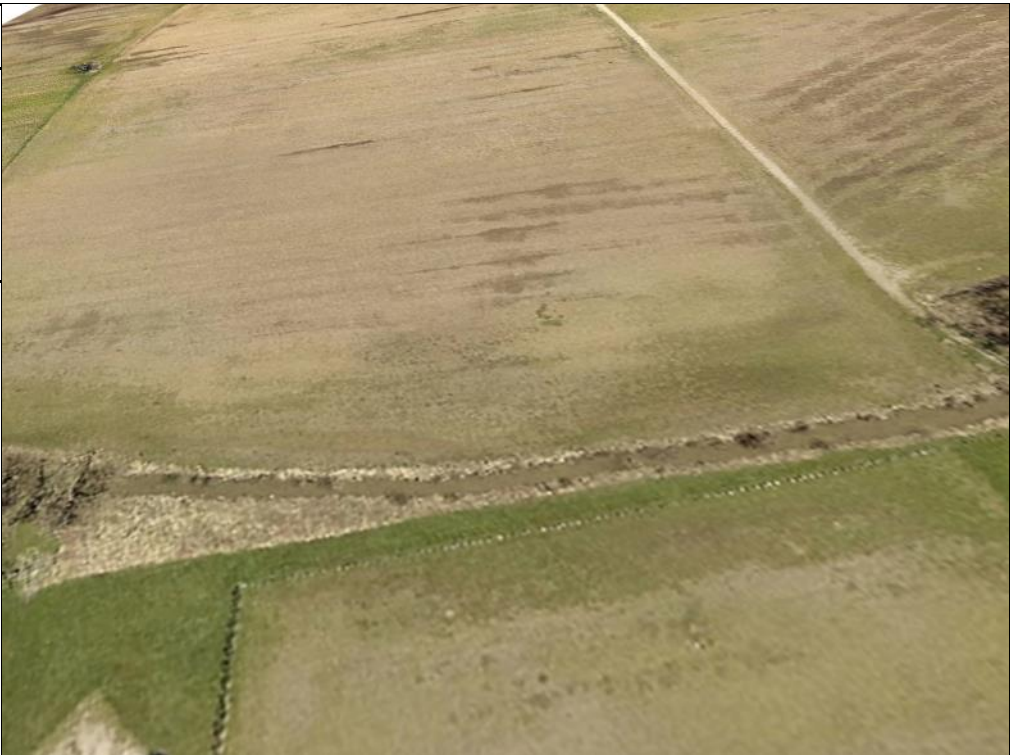
Photo No. 9	Date: 2017

Direction Photo Taken: South		
Description: Aerial view of pre-construction conditions at Fortune Ditch.

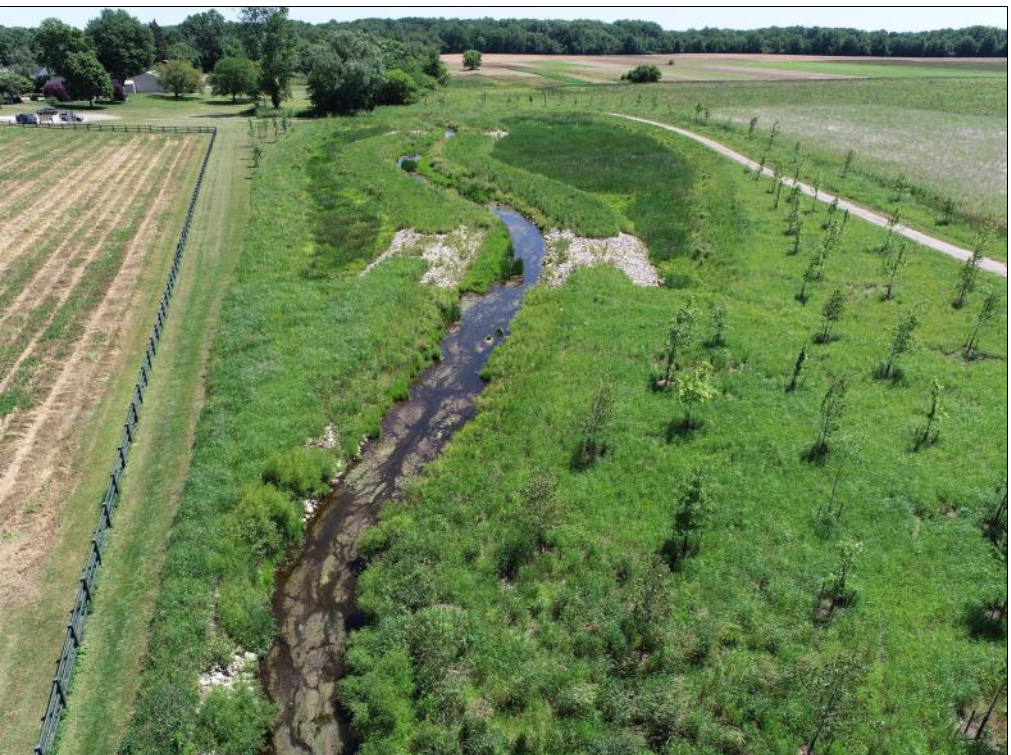
Photo No. 14	Date: 6/16/2021

Direction Photo Taken: East		
Description: Post-construction view of floodplain wetlands and restored riparian buffer along Fortune Ditch.

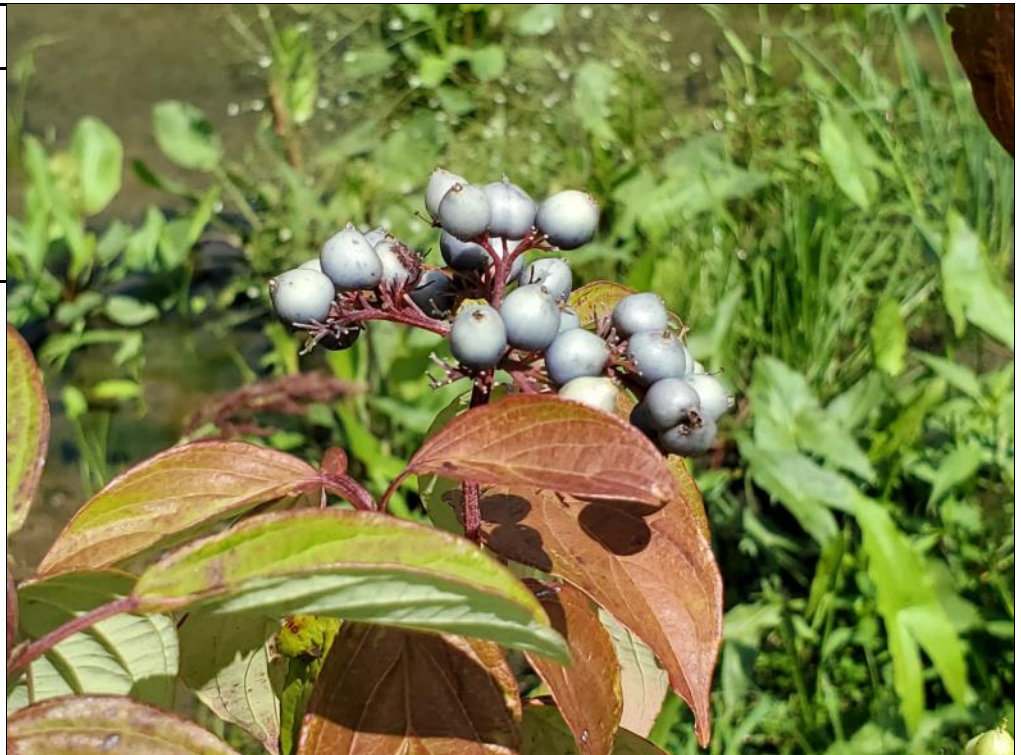
Photo No. 15	Date: 8/14/2019
Direction Photo Taken: N/A	
Description: View of robust dogwood shrub planting and multiple obligate wetland species within the constructed floodplain wetlands.

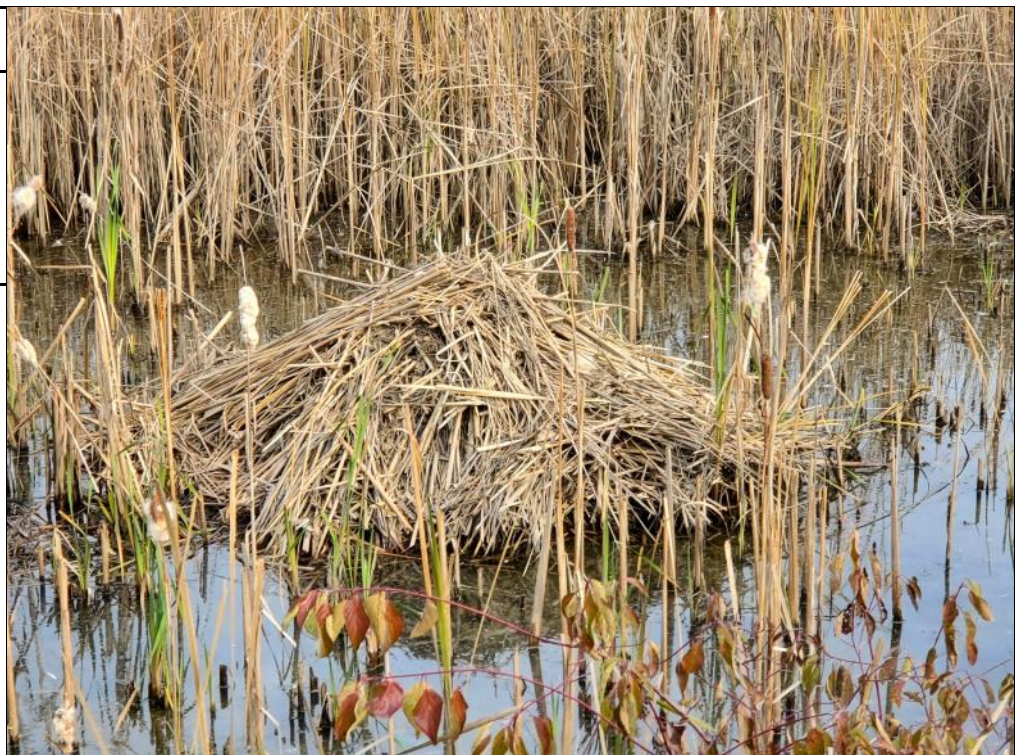
Photo No. 16	Date: 11/11/2021
Direction Photo Taken: N/A	
Description: One of several substantial muskrat lodges observed within the constructed floodplain wetlands.

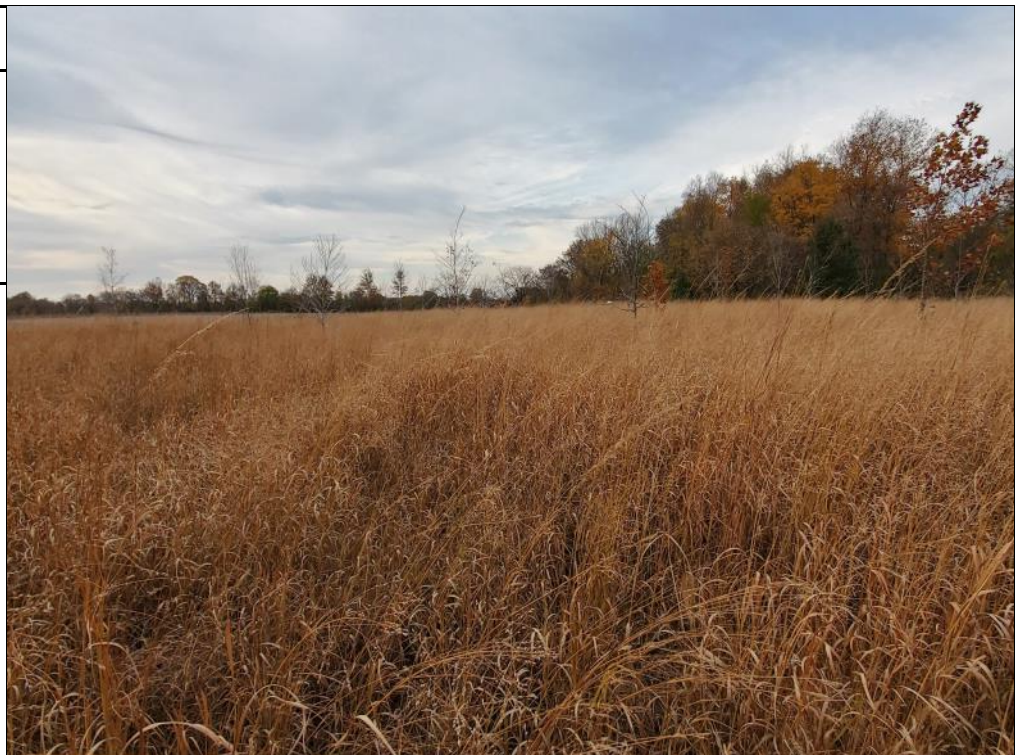
Photo No. 17	Date: 11/11/2021
Direction Photo Taken: Southwest	
Description: View of oak savanna and grassland restoration adjacent to Fortune Ditch at the Margaret Peak Nature Preserve.

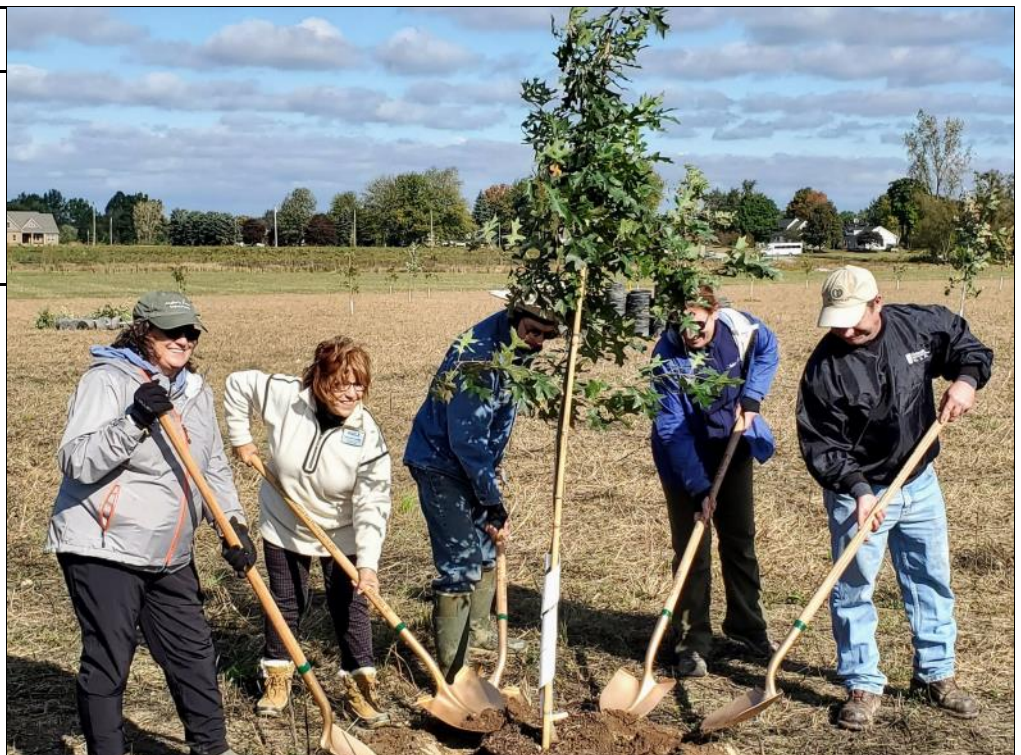
Photo No. 18	Date: 10/12/2019
Direction Photo Taken: Northeast	
Description: One of 400 trees planted by volunteers to support oak savanna restoration at the Margaret Peak Nature Preserve.
